# Nuovo Pignone 6B Gas Turbine Shell Crack Repair

Repaired Dec. 2009

Torino, Italy

Cofely Italia S.p.A.

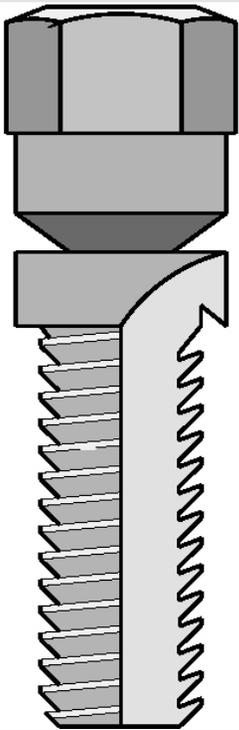
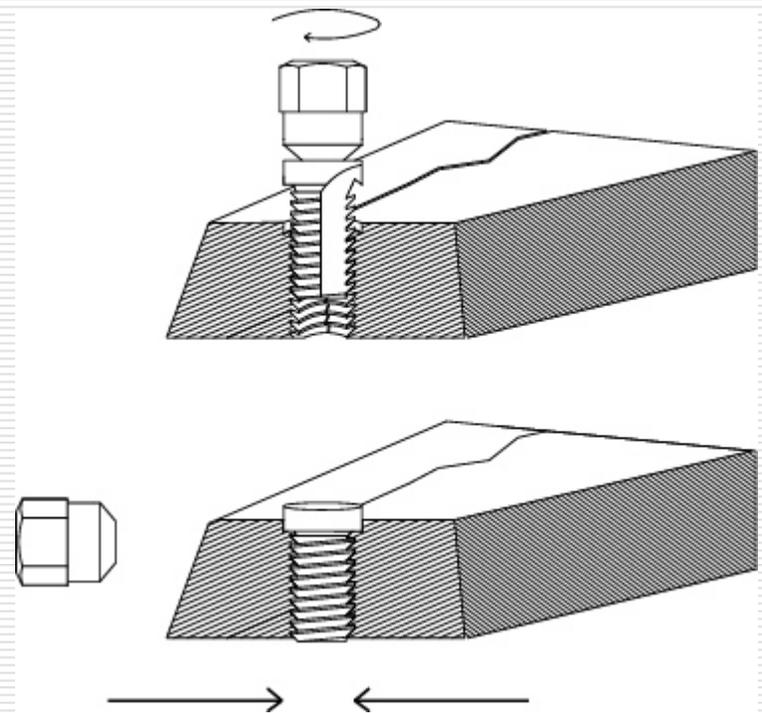
# CASTMASTER® Stitching Pins

**CASTMASTER stitching pins have the unique ability to draw the sides of a crack together when tightened into the drilled, Spotfaced and tapped hole.**

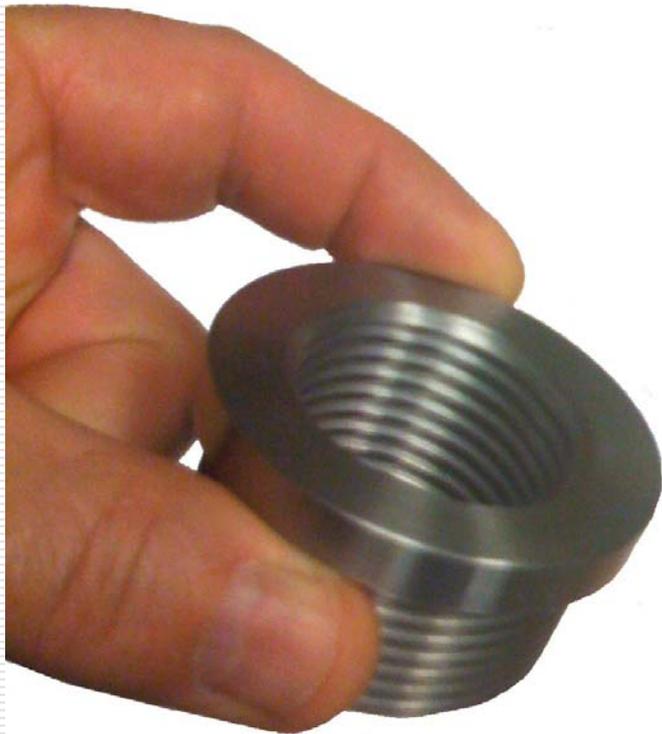
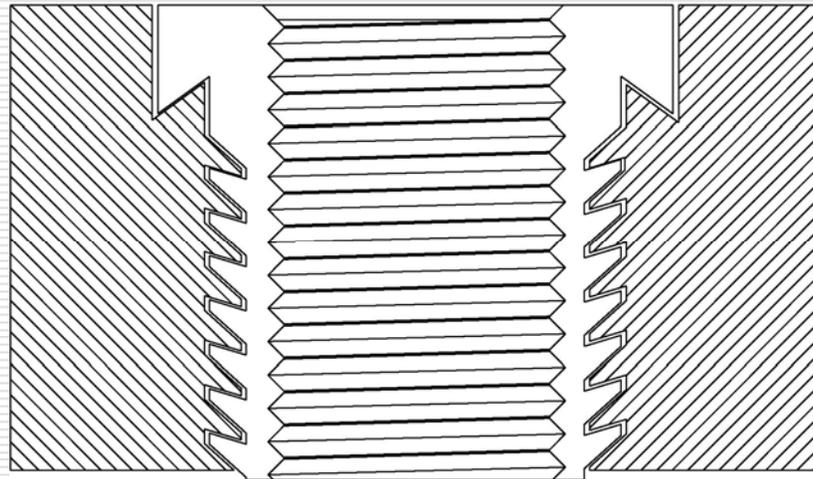
# Full-Torque FST Style Insert

Full-Torque thread repair inserts are made with our patented Spiralhook threads on the outside and standard threads on the inside. The shoulder seats into a special machined spotface that adds to the drawing force when installed.
