Sacramento City flood control pump, capacity 5 Million gallons per day

The pump discharge port flange cracked during replacement of the gate valve

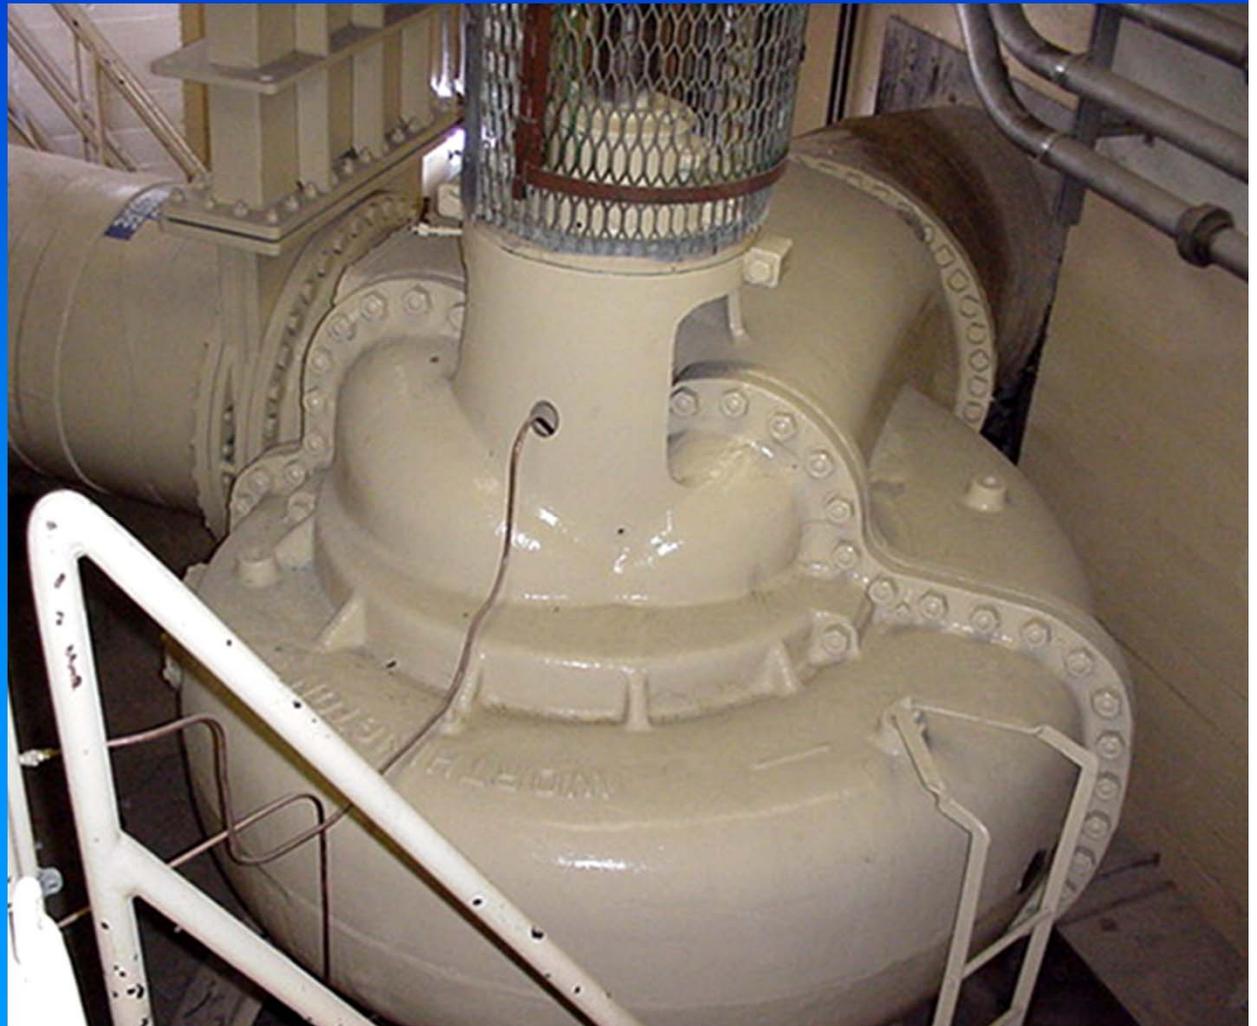
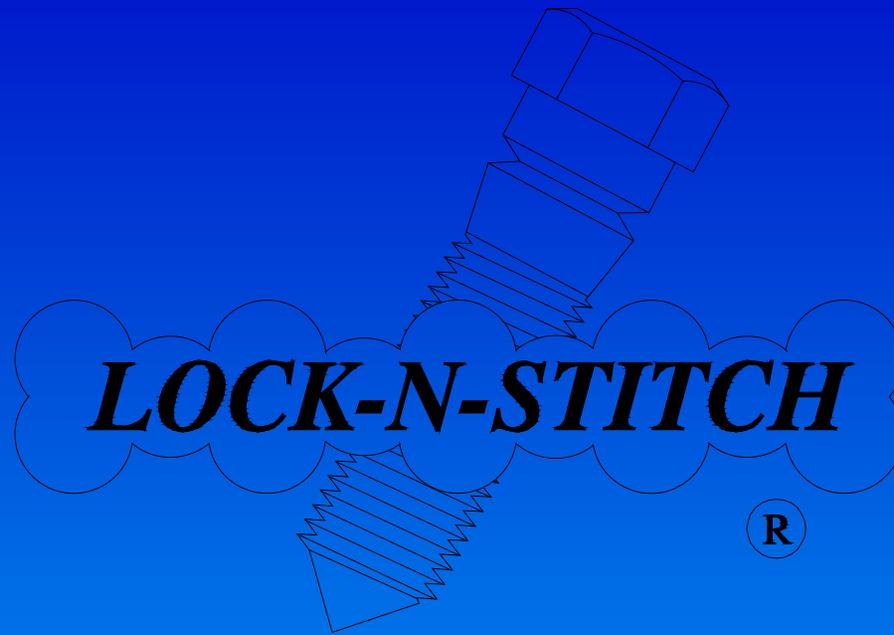
Total repair time was three weeks. The pump was manufactured in 1919 and the damaged half could not be replaced.

A new pump would cost over 1 million dollars to install.

The total repair price was \$80,000.00.

The repair was completed in
2001 and is still in service today
