Sea Escape Casino Vessel FT Lauderdale, Florida 2001

Wartsila 8 cyl. diesel generator

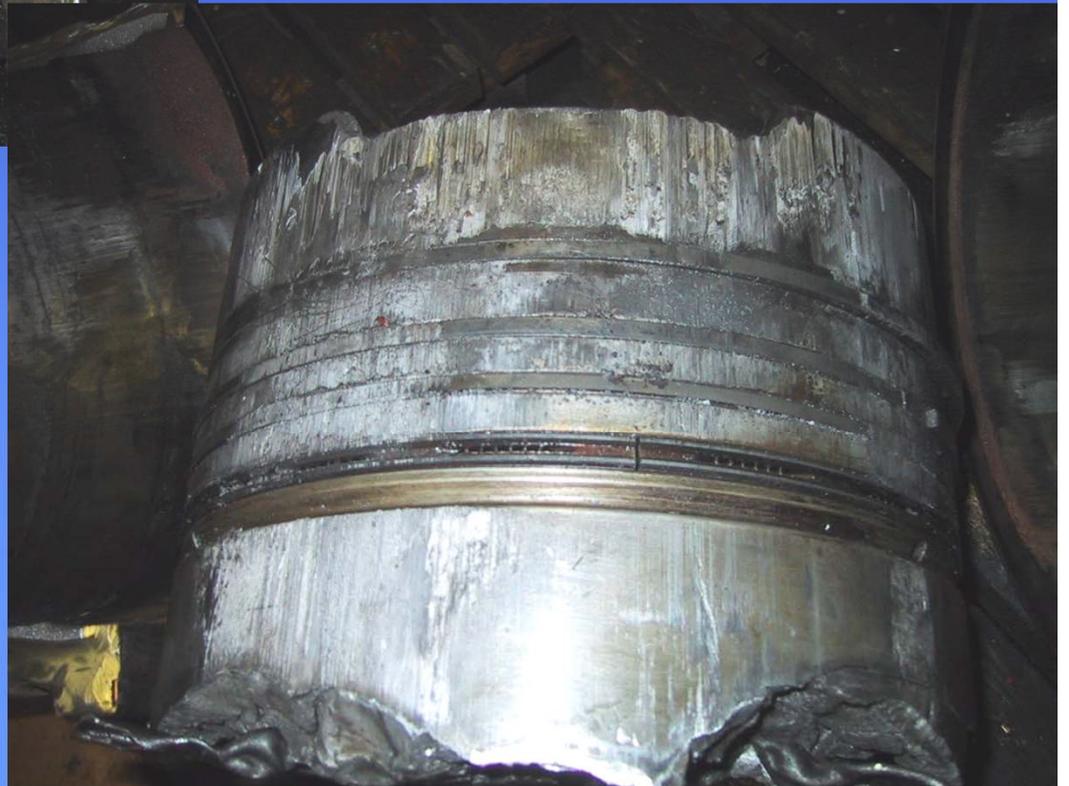
The damage was caused by a seized piston.

The piston split at the wrist pin and the connecting rod smashed out the bottom liner bore and cracked the outside water jacket.
