Final Repor

Date <u>10-16-12</u>

Part 302 B Crank Case

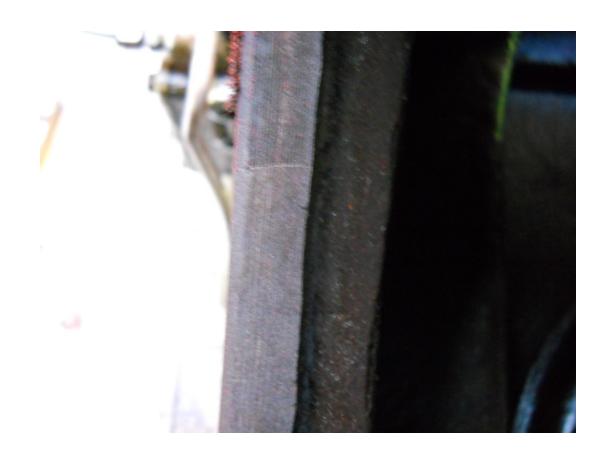
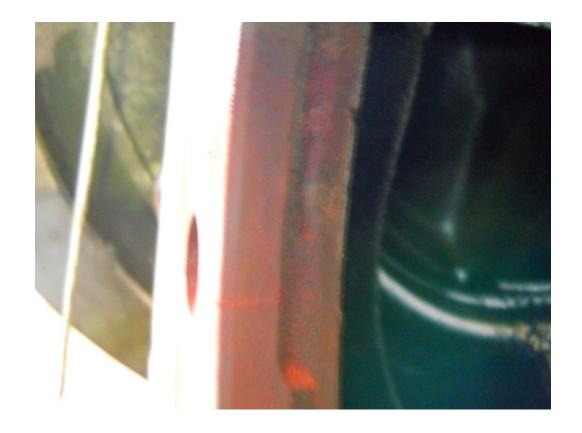
Found—Inspection shows 7 inches of crack and 3 bad bolt holes.

Beginning stitching process on the flange portion of the crank case.
