**Recent *LOCK-N-STITCH* repairs on large steel and cast iron parts**

Cracked water strainer casting for Hydro-electric plant in California

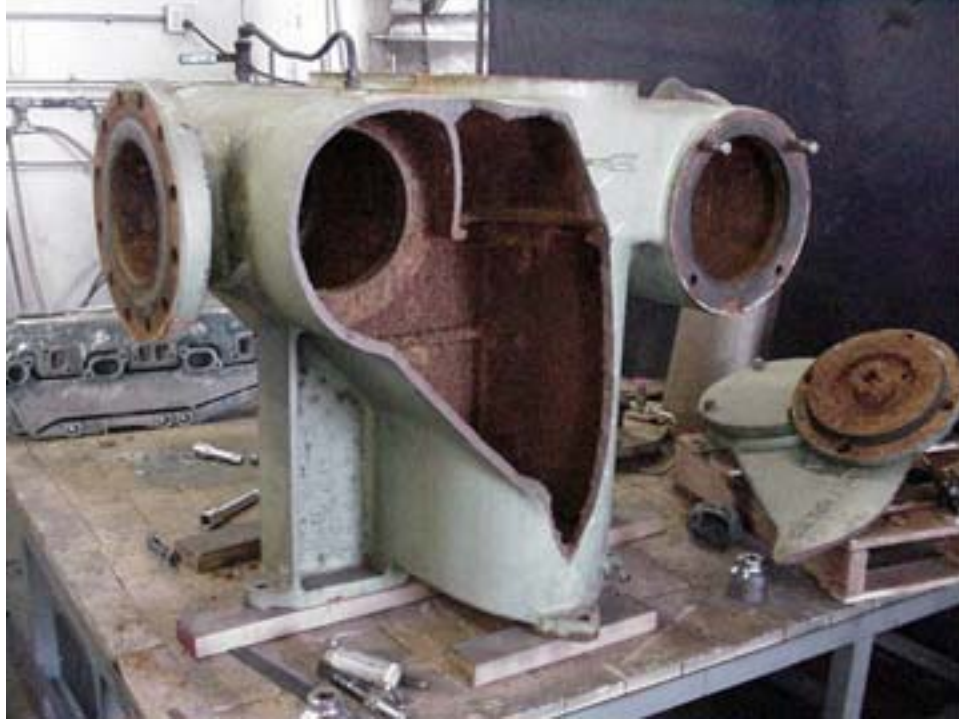
Over pressurization blew the side out of this casting.
